INSPECTION REPORT

From:	rom: Troika Inspection Service Co., Ltd		xxxxxxx
Project No.:	: XXXXXXXXX		
Vendor Name	: xxxxxxxxx		
Factory Name	: xxxxxxxxx		
Factory Address	: xxxxxxxxx		A O
Order No. / PO No.	: xxxxxxxxx		
Product description:	: Pressure Vessel		
Inspection Date:	• ۷۷۷۷۷۷۷

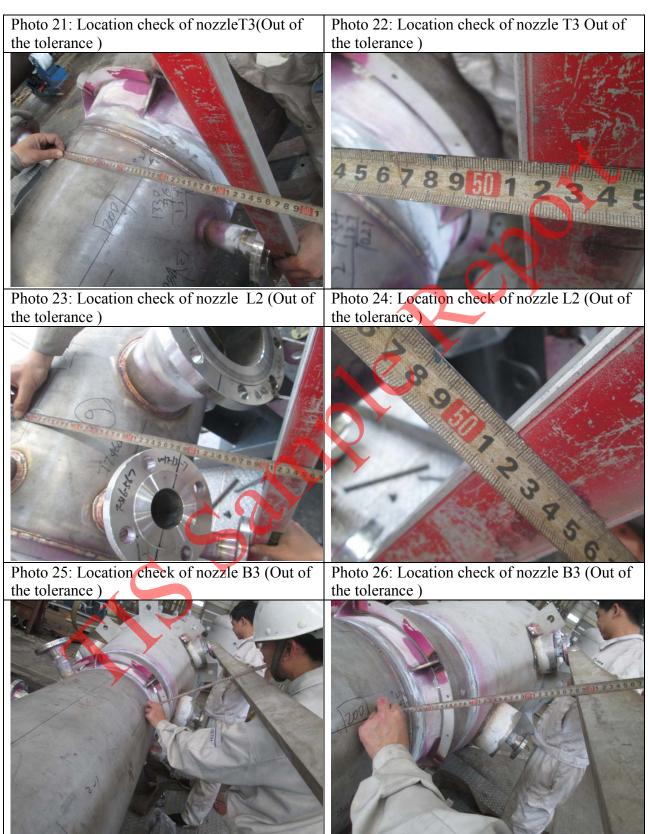
- --Nozzle location issue as below, the result was unacceptable:
- ---Nozzle T3: The distance of flange face to center line drawing request is 408mm (+/-3mm), actual measure is 414/412mm.
- ---Nozzle L2: The distance of flange face to center line drawing request is 408mm (+/-3mm), actual measure is 414/412mm.
- ---Nozzle B3: The distance of flange face to center line drawing request is 625mm (+/-3mm), actual measure is 635/639mm.
- ---Nozzle H1 with Nozzle B1 (Top head) has interference after blind installation completed, mill through the removal of part of the hand hole flange, to ensure the normal installation.

Photo 27: Nozzle H1 with Nozzle B1 (Top Photo 28: SHTH through the removal of part of head) has interference after blind installation the hand hole flange, to ensure the normal completed. installation. Photo 29: LPT of seam of skirt with head of Photo30: Test panel item 445-01-204 (weld joint: E36 and FB1) Photo 31: LPT of test panel Photo 32: LPT of seam of skirt with head of item 445-01-204 (weld joint: E36 and FB1)

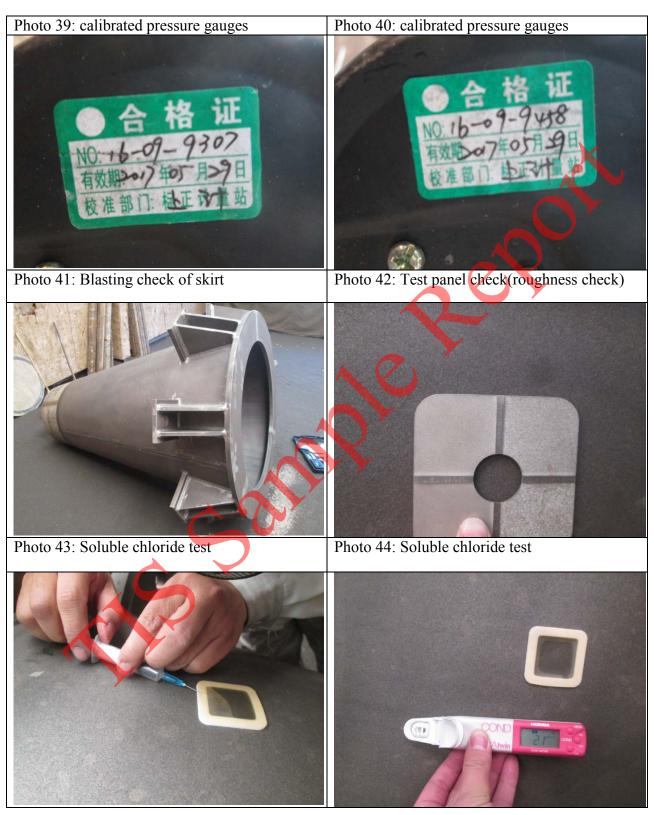
-TIS inspector witnessed leakage test of reinforcement pad of nozzle(A3) of item 445-01-204, including calibrated pressure gauges, test pressure, holding time, the solution of SNOOP. No leakage, no visible deformation and no abnormal noise was found, the result were acceptable as note according to ITP (Doc No.: TH16--ITP-LMHS-002, Rev. C), Drawing (DWG No.:ST16-00-305-00, Rev.01) and GB/T150-2011. (Note: mill stated the calibration certificate of gauges will be provided later.)

-TIS inspector witnessed the hydro test of item 445-01-204, including test pressure, test medium, held time, calibrated pressure gauges and water quality certificate(Chloride), no leakage, no visible deformation and no abnormal noise was found during test, the results was acceptable as note according to ITP (Doc No.: TH16--ITP-LMHS-002, Rev. C), Drawing (DWG No.:ST16-00-305-00, Rev.01), GB/T150-2011 and Dow specification G8S-4001-60(19-Apr-2011)/G9S-1000-01(11-APR-2013).(Note: mill stated the calibration certificate of gauges will be provided later.)

Photo 33: Leakage test of reinforcement of Photo 34: The solution of SNOOP nozzle A3 Snoop Photo 35: The calibration label of pressure Photo 36: The calibration label of pressure gauge gauge Photo 37: The hydro test Photo 38: Test pressure
