## INSPECTION REPORT

To:	xxxxxxx	Attn:	xxxxxxx
From:	Troika Inspection Service Co., Ltd	Report Date:	xxxxxxx

Project No.:	:	xxxxxxxxx
Vendor Name	:	xxxxxxxxx
Factory Name	:	xxxxxxxxx
Factory Address	:	xxxxxxxxx
Order No. / PO No.	:	xxxxxxxxx
Product description:	:	Heat Exchanger
Inspection Date:	:	xxxxxxxxx

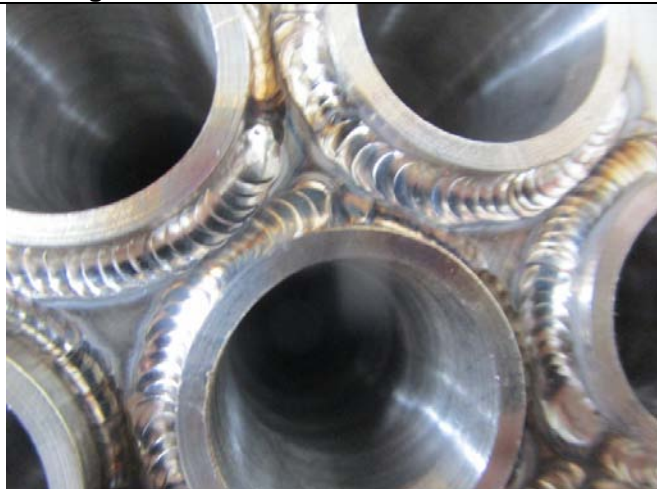
**Photo 1. Visual check of tube-to-tube sheet during welding**

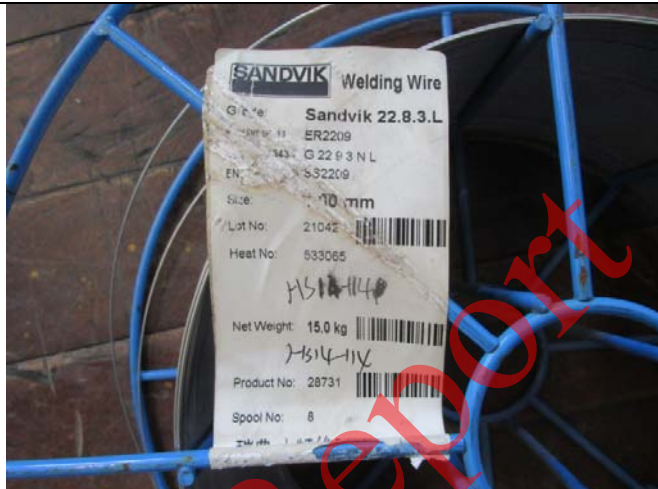
- TIS inspector performed welding check of tube-to-tube sheets including welding consumable(ER2209,Φ1.0, I.D. No.:HS14-114), welding parameter, welding position and welder's qualification(W20, W28 and W110 for filler layer welding, W110, W28 and W43 for cover layer welding), the results were acceptable according to drawing no.:ZS16-E227-01, Rev.4 and WPS(TTW-034, rev.0) that submitted by mill;

**Photo 2. Welding consumable check**

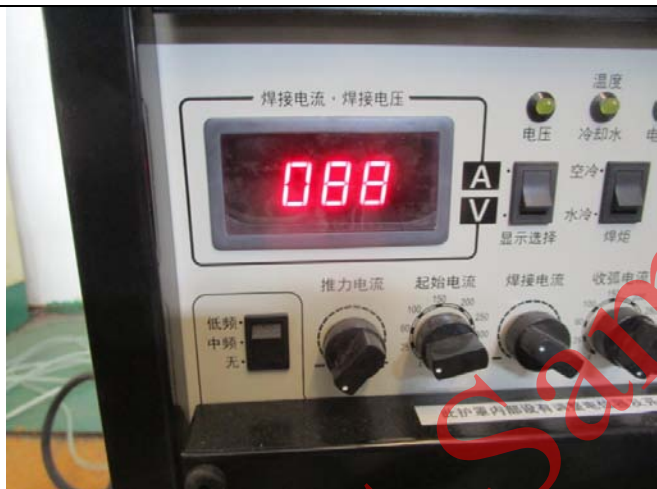
**Photo 3. Welding parameter check**

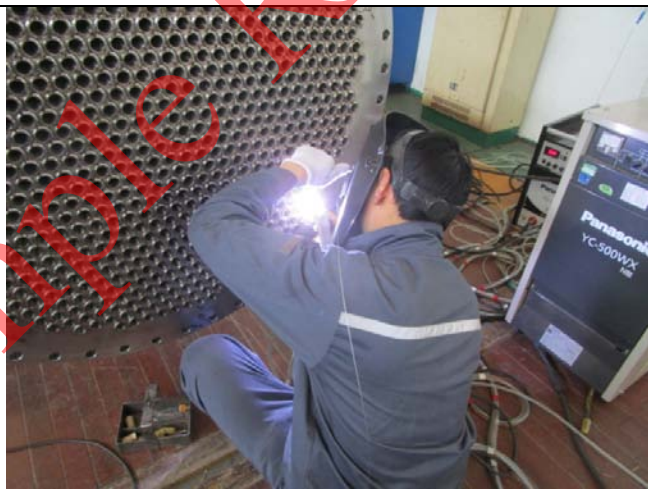
**Photo 4. Process of welding**

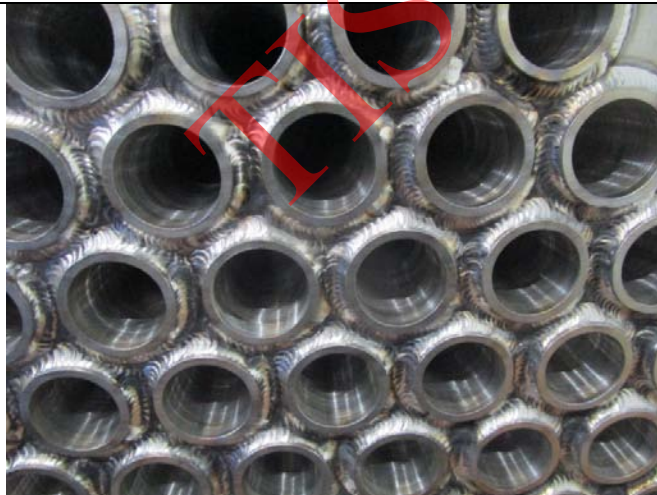
**Photo 5. Visual check of tube-to-tube sheet**

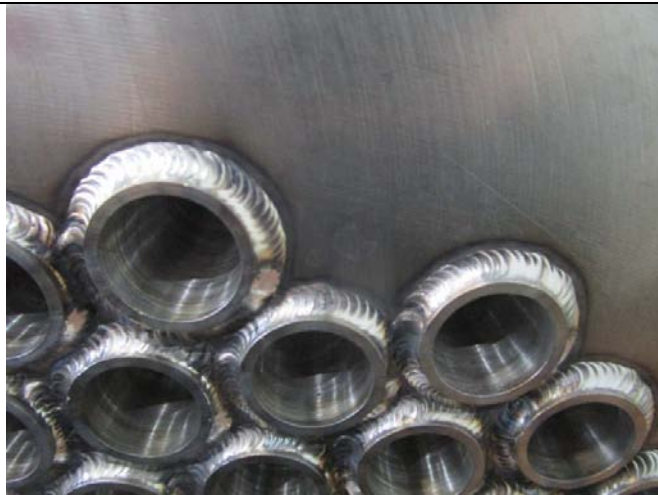
**Photo 6. Visual check**

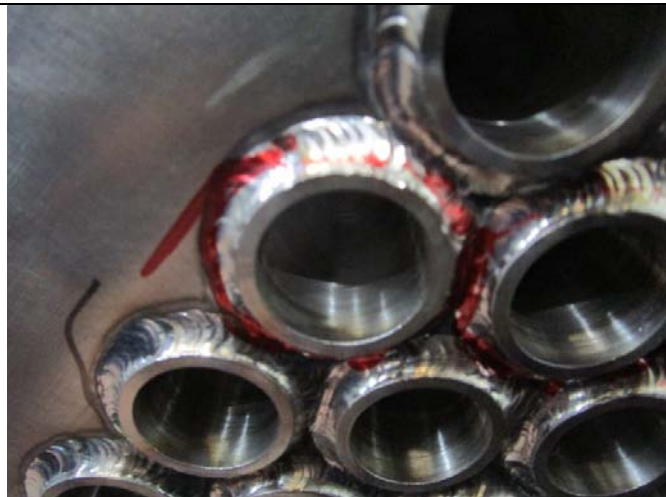
- TIS inspector performed visual check of tube-to-tube sheets of filler layer and cover layer, and 7pcs catch up tube ends were found at top tube sheets. After confirming with Dow SME at mill workshop, one additional layer was welding by mill for the 7pcs tubes. No defect and no burn through was found, the final results were acceptable according to drawing no.: ZS16-E227-01, Rev.4 and Dow specification G9S-3000-01(17-Feb-2016).

Photo 7. Catch up tube end

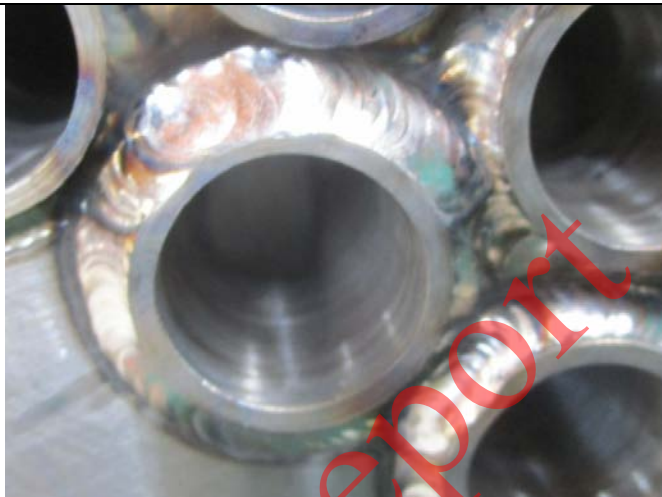
Photo 8. Additional layer for catch up tubes

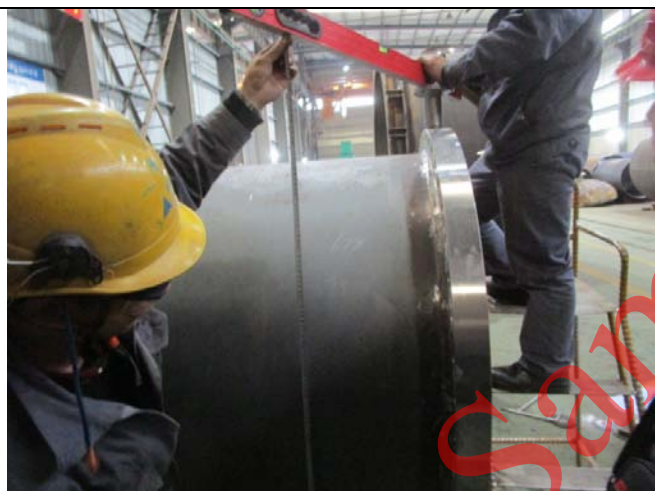
- TIS inspector performed fitting-up check of nozzle (V1&V2) to tube sheets including nozzle orientation check, gap check, projection length from center line check, and found nozzle orientation according to drawing cannot get enough fillet weld size because nozzle O.D. is almost flush with the edge of tube sheets' bolt area. After confirming with XXX at mill workshop, the orientation of V1 and V2 had been adjusted(center of thickness of tube sheet's bolt area) in order to get enough fillet weld size.

Photo 9. Fitting-up check of nozzle V1&V2

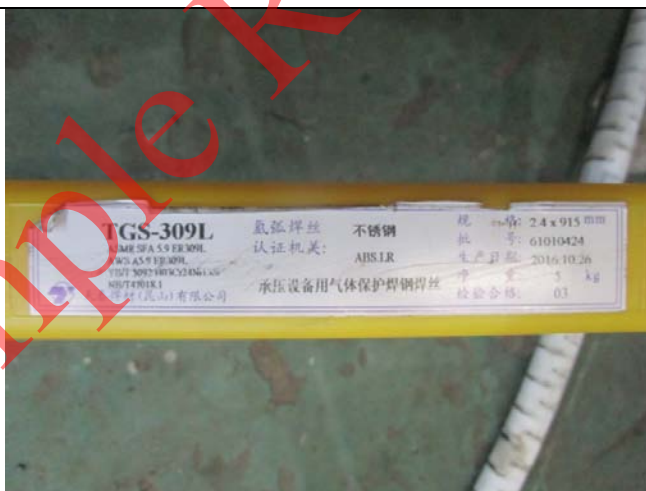
Photo 10. Fitting-up check: tack weld's filler metal

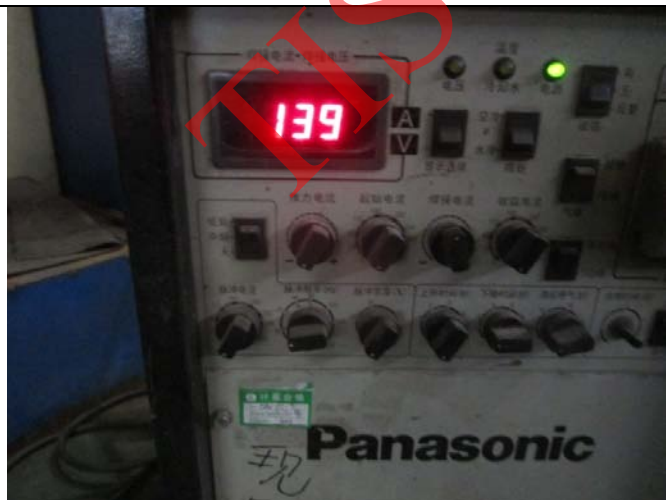
Photo 11. Fitting up check of V1&V2: tack welding parameter

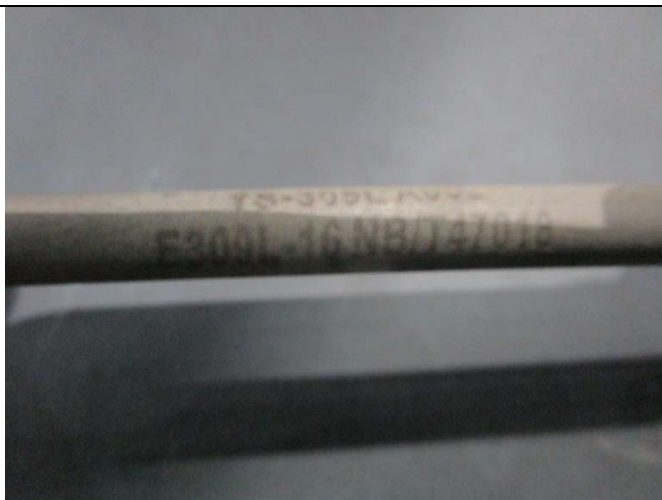
Photo 12. Welding check of C1&C2: filler metal check

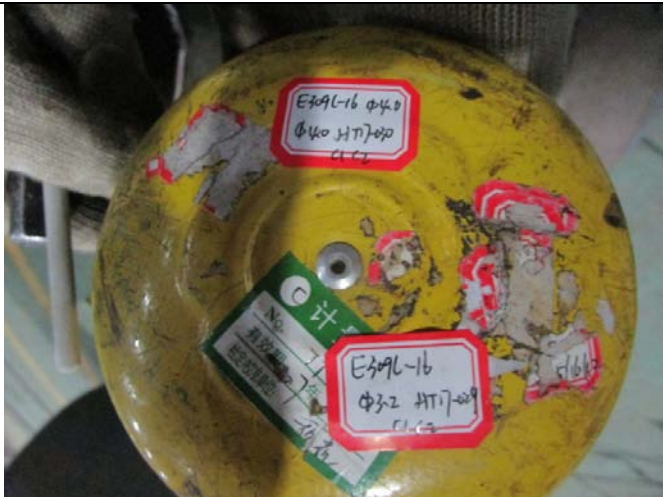
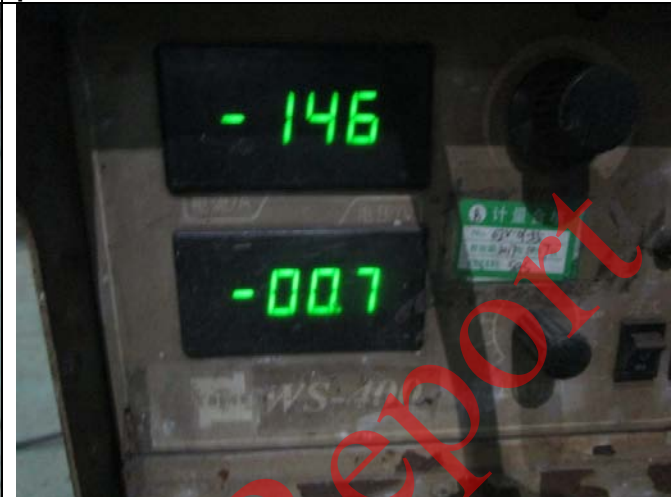
<b>Photo 13. Welding check of C1&amp;C2: filler metal check</b>	<b>Photo 14. Welding check of C1&amp;C2: welding parameter check</b>

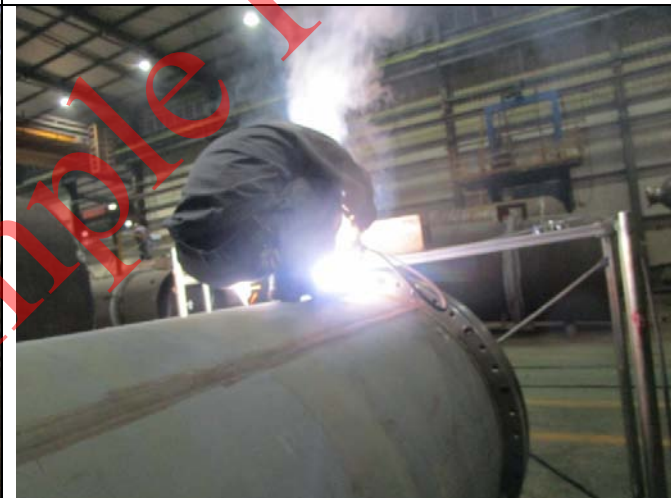
<b>Photo 15. Welding check of C1&amp;C2: Cleaning check</b>	<b>Photo 16. Welding check of C1&amp;C2: witness process of welding</b>

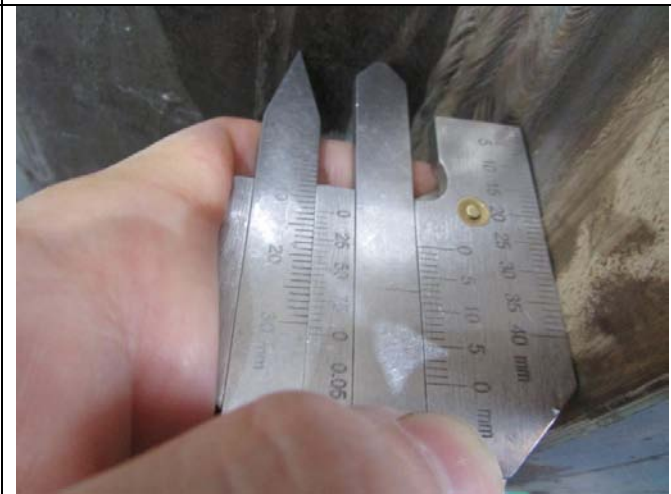
- TIS inspector performed visual check of weld (C1&C2) of shell to tube sheet including weld seam appearance, fillet weld size, the results were acceptable according to drawing no.:ZS16-E227-03, rev.03, ASME VIII.1-2015 and Dow specification G8S-6500-01(25-Jan-2016).

<b>Photo 17. Visual check of C1&amp;C2: Weld size check</b>	<b>Photo 18. Visual check of C1&amp;C2: Weld size check</b>

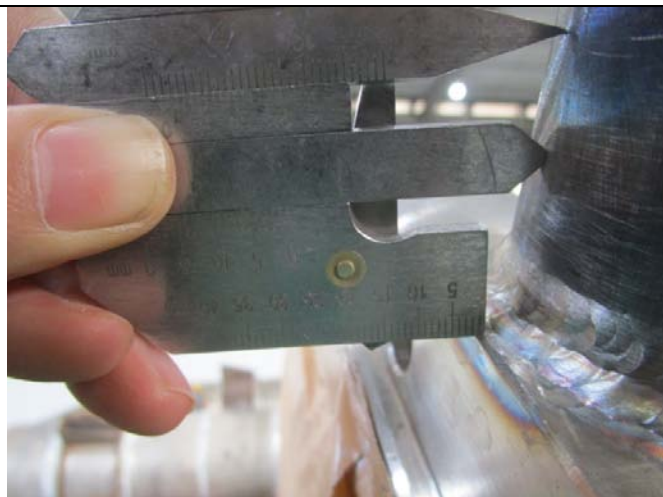
- TIS inspector performed visual check of weld of nozzle (V1&V2) to tube sheet including weld visual quality, fillet weld size, the results were acceptable according to drawing no.: ZS-ES227-01, rev. 4& ZS-E227-03, rev.3 and Dow specification G8S-6500-01(25-JAN-2016).

Photo 19. Visual check of V1&V2: Weld size check

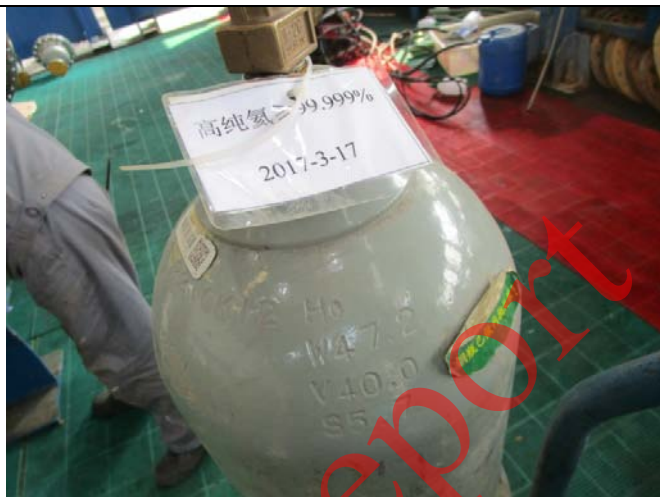
Photo 20. Helium test: Gas check

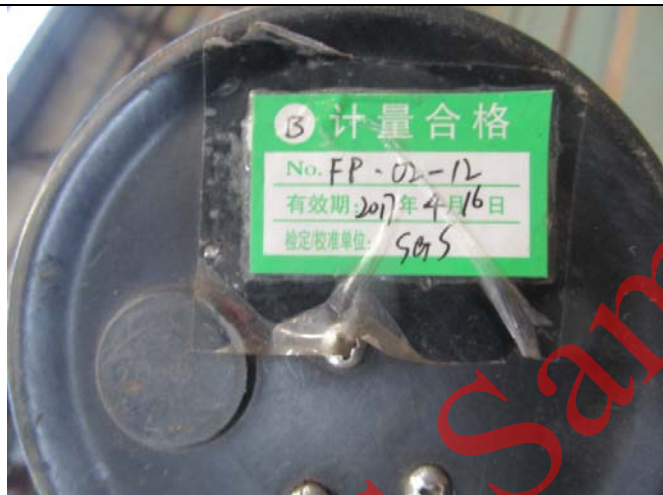
Note: No helium equipment calibration certification was submitted by mill for reference till end of the visit. The standard leak detector and pressure gauges were calibrated.

Photo 21. Helium test: Pressure gauge with calibration label

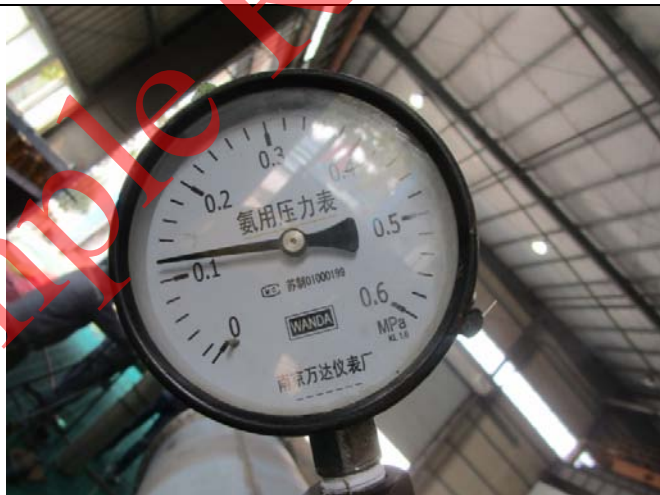
Photo 22. Helium test: He pressure

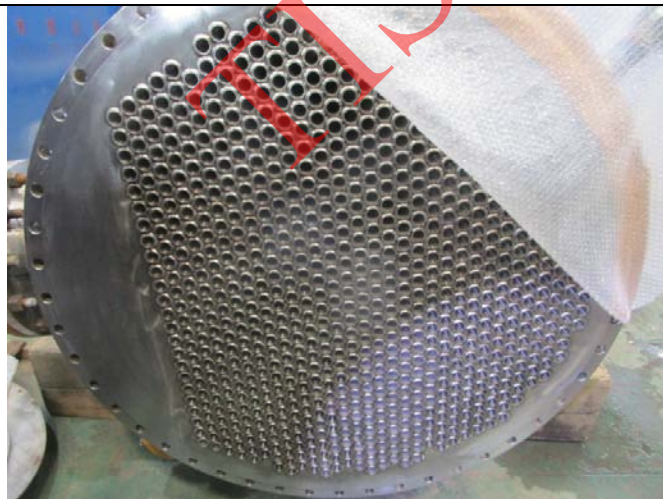
Photo 23. Helium test: Cleaning check before helium test

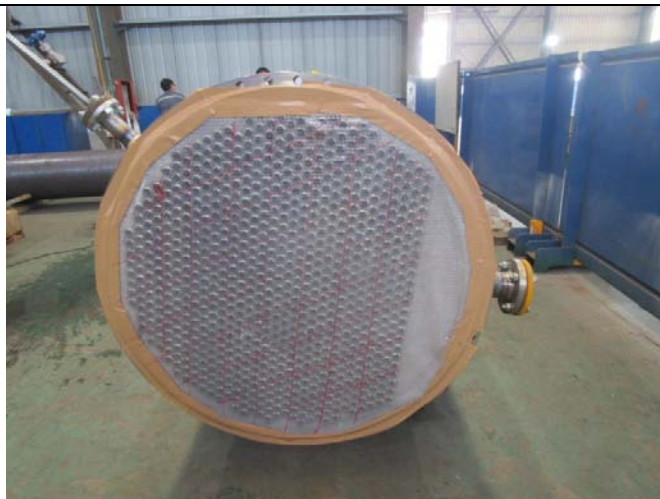
Photo 24. Helium test: prepared before helium test

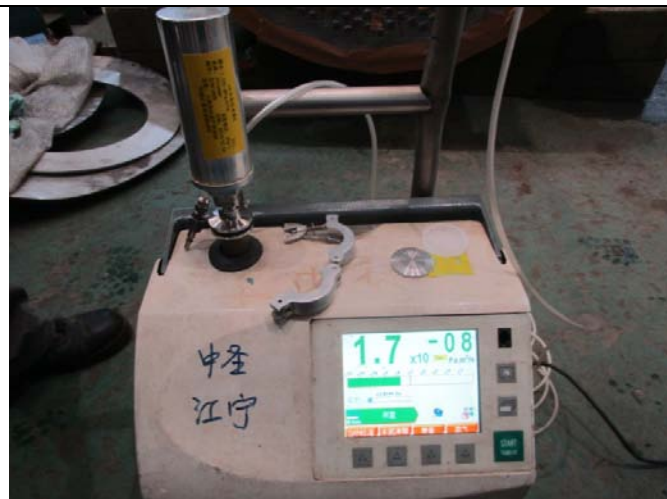
Photo 25. Helium test: Calibration equipment

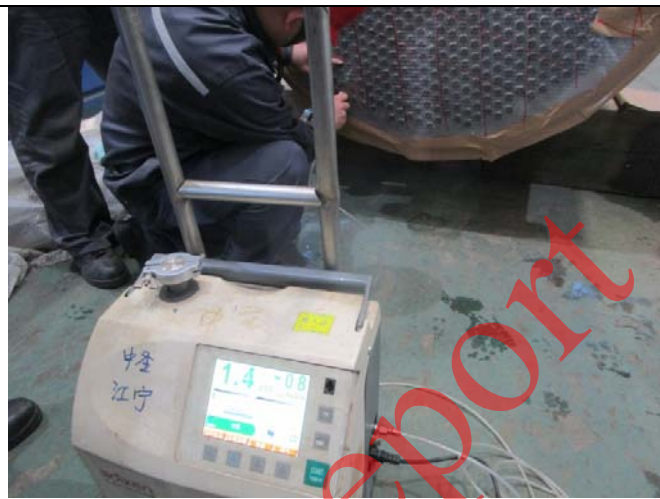
- XXX and TIS inspector performed helium test for tubes and tube-to-tube sheets joints including calibrate equipment by standard leak detector, test pressure (3.2bar), helium volume percentage (30%), soaking time, and no leak rate is out of acceptable criteria, the results were acceptable with note according to Dow specification G8S-5031-03(28-Jan-2011) and helium procedure submitted by mill.

Photo 26. Helium test: Witness helium test

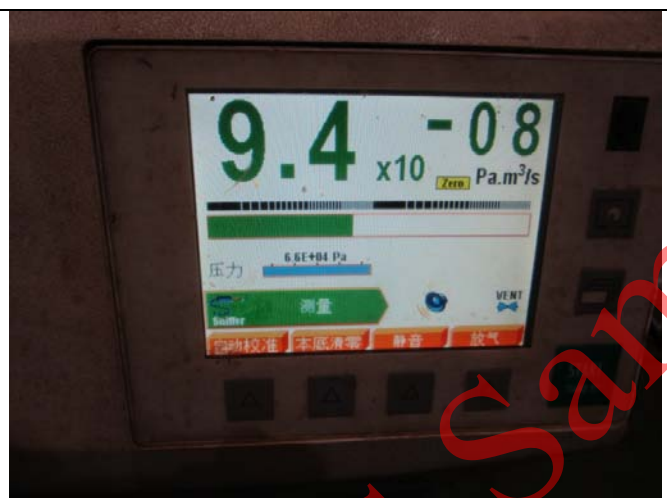
Photo 27. Helium test: Max. helium leak rate

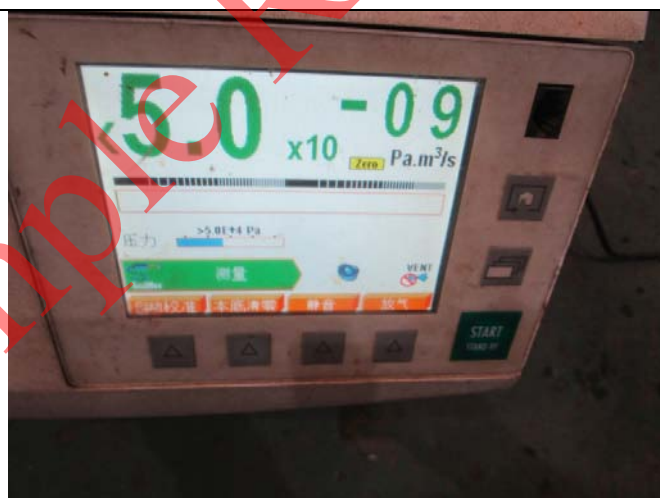
Photo 28. Helium leak rate without background gas affect

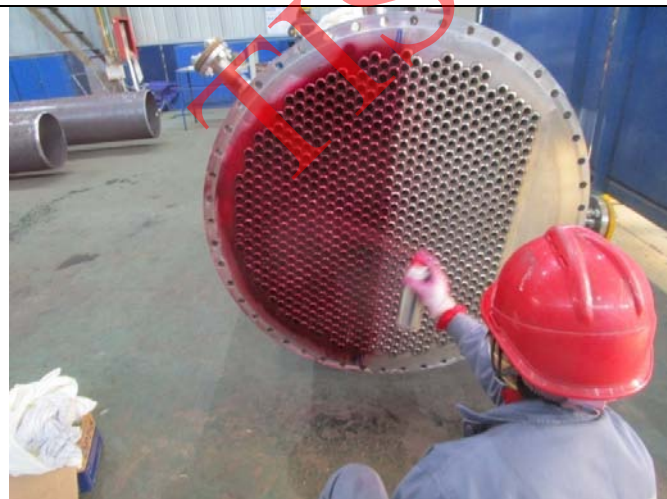
Photo 29: PT witness

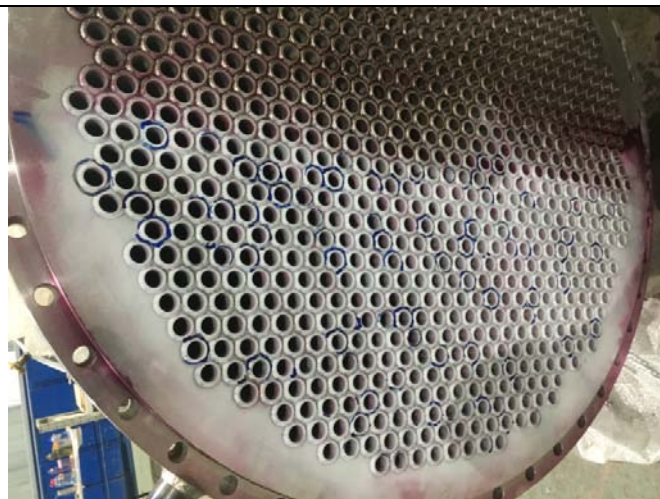
Photo 30: PT check for weld of bottom tube-to-tube sheets

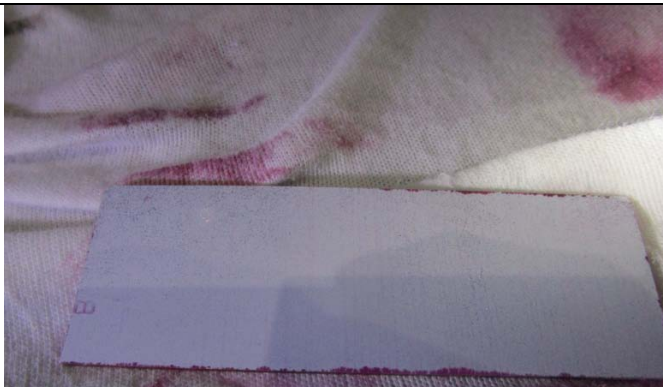
Photo 31: Test Panel	Photo 32: Linear indications were found

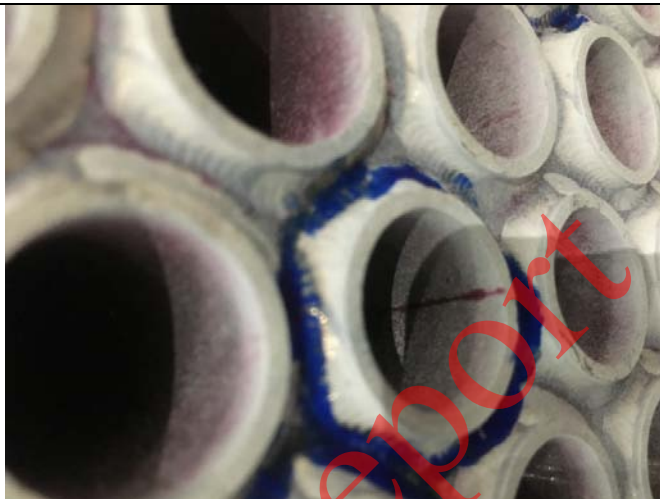
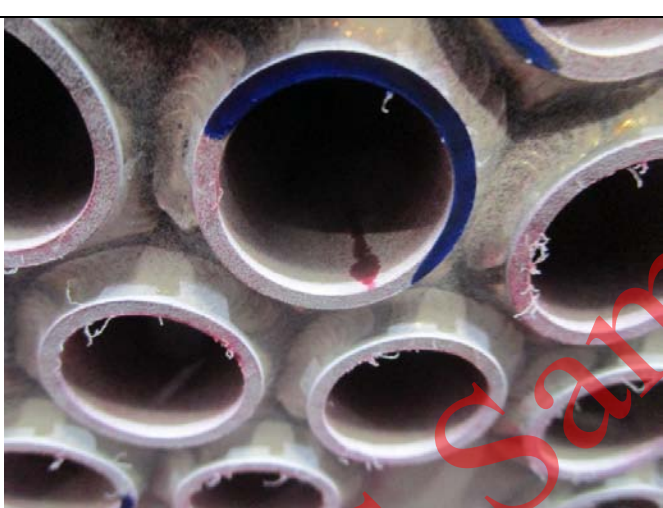
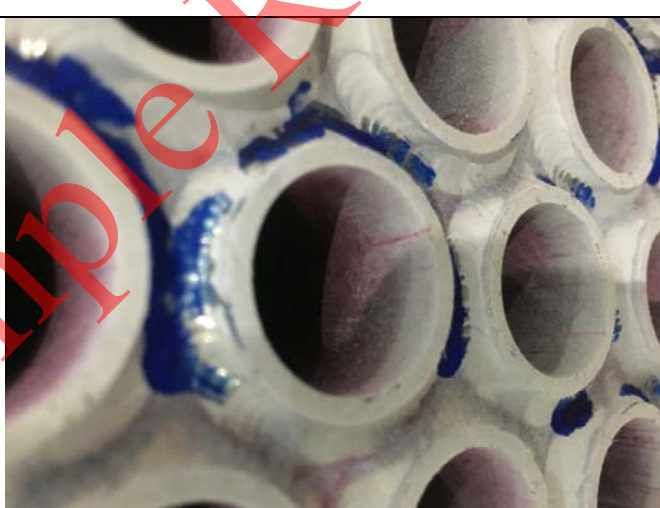
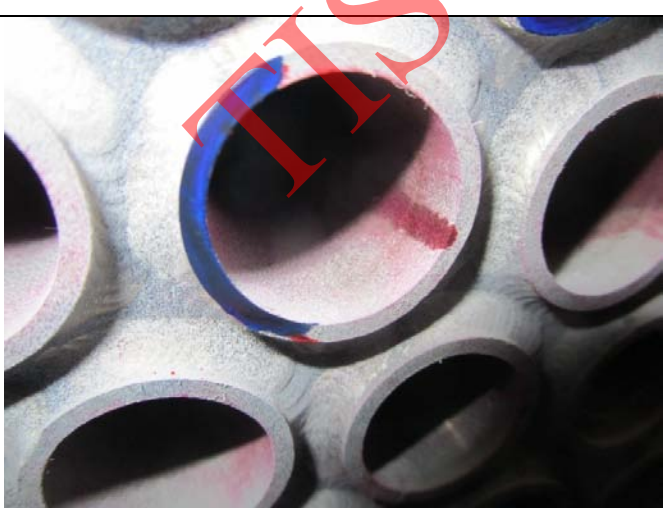
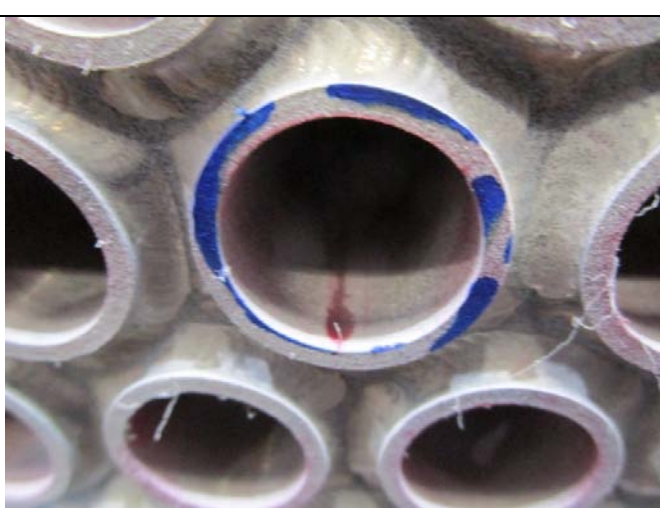
- XXX and TIS inspector witnessed PT before tube expansion for weld and HAZ of tube-to-tube sheets joints including test panel, and 215pcs tubes' end of inside surface showed linear indications on bottom tube-to-tube sheets and 185pcs tubes' end of inside surface showed linear indications on top tube-to-tube sheets. The results were pending.

Photo 33: Linear indications were found	Photo 34: Linear indications were found

Photo 35: Linear indications were found	Photo 36: Linear indications were found

Befroe to next step, the mill should confirm it with client for the above findings.
