INSPECTION REPORT

From:	Troika Inspection Service Co., Ltd		Report Date:	xxxxxxx
Project No.:	:	XXXXXXXX		
Vendor Name	:	xxxxxxxx		
Factory Name	:	xxxxxxxx		
Factory Address	:	xxxxxxxx		A O
Order No. / PO No.	:	xxxxxxxx		
Product description:	:	Heat Exchanger		
Inspection Date:		YYYYYYYY

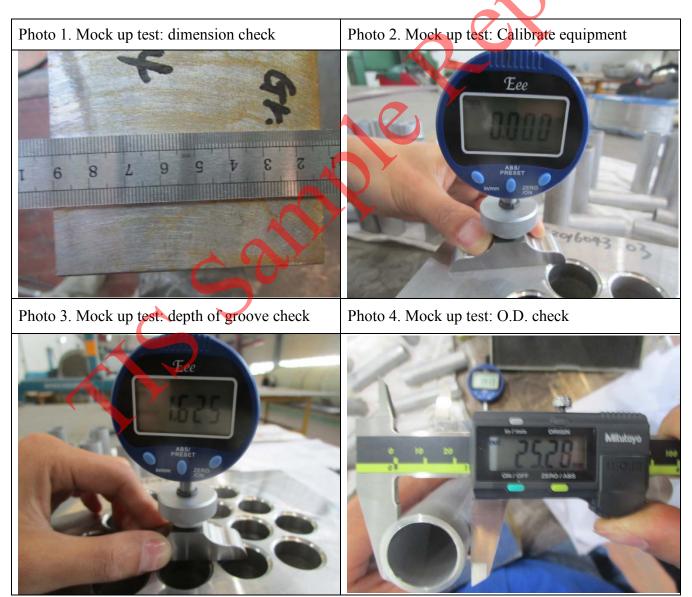
Photo 5. Mock up test: I.D. check Photo 7. Mock up test: welding consumable

Photo 6. Mock up test: projection length check

- 4.4.4 Welding witness of mock up test specimens
- TIS inspector performed the assembly and welding check of mock up test specimen of E-10 of YSMUT2016043-05 including tube projection length check, welding consumable check, welders' name and welding parameter check, the result was failed because cracks were found during root layer welding.
